CALIFORNIA DIVISION OF MINES AND GEOLOGY

FAULT EVALUATION REPORT FER-99

SEPTEMBER 24, 1980

San Andreas and Harris Ranch faults.

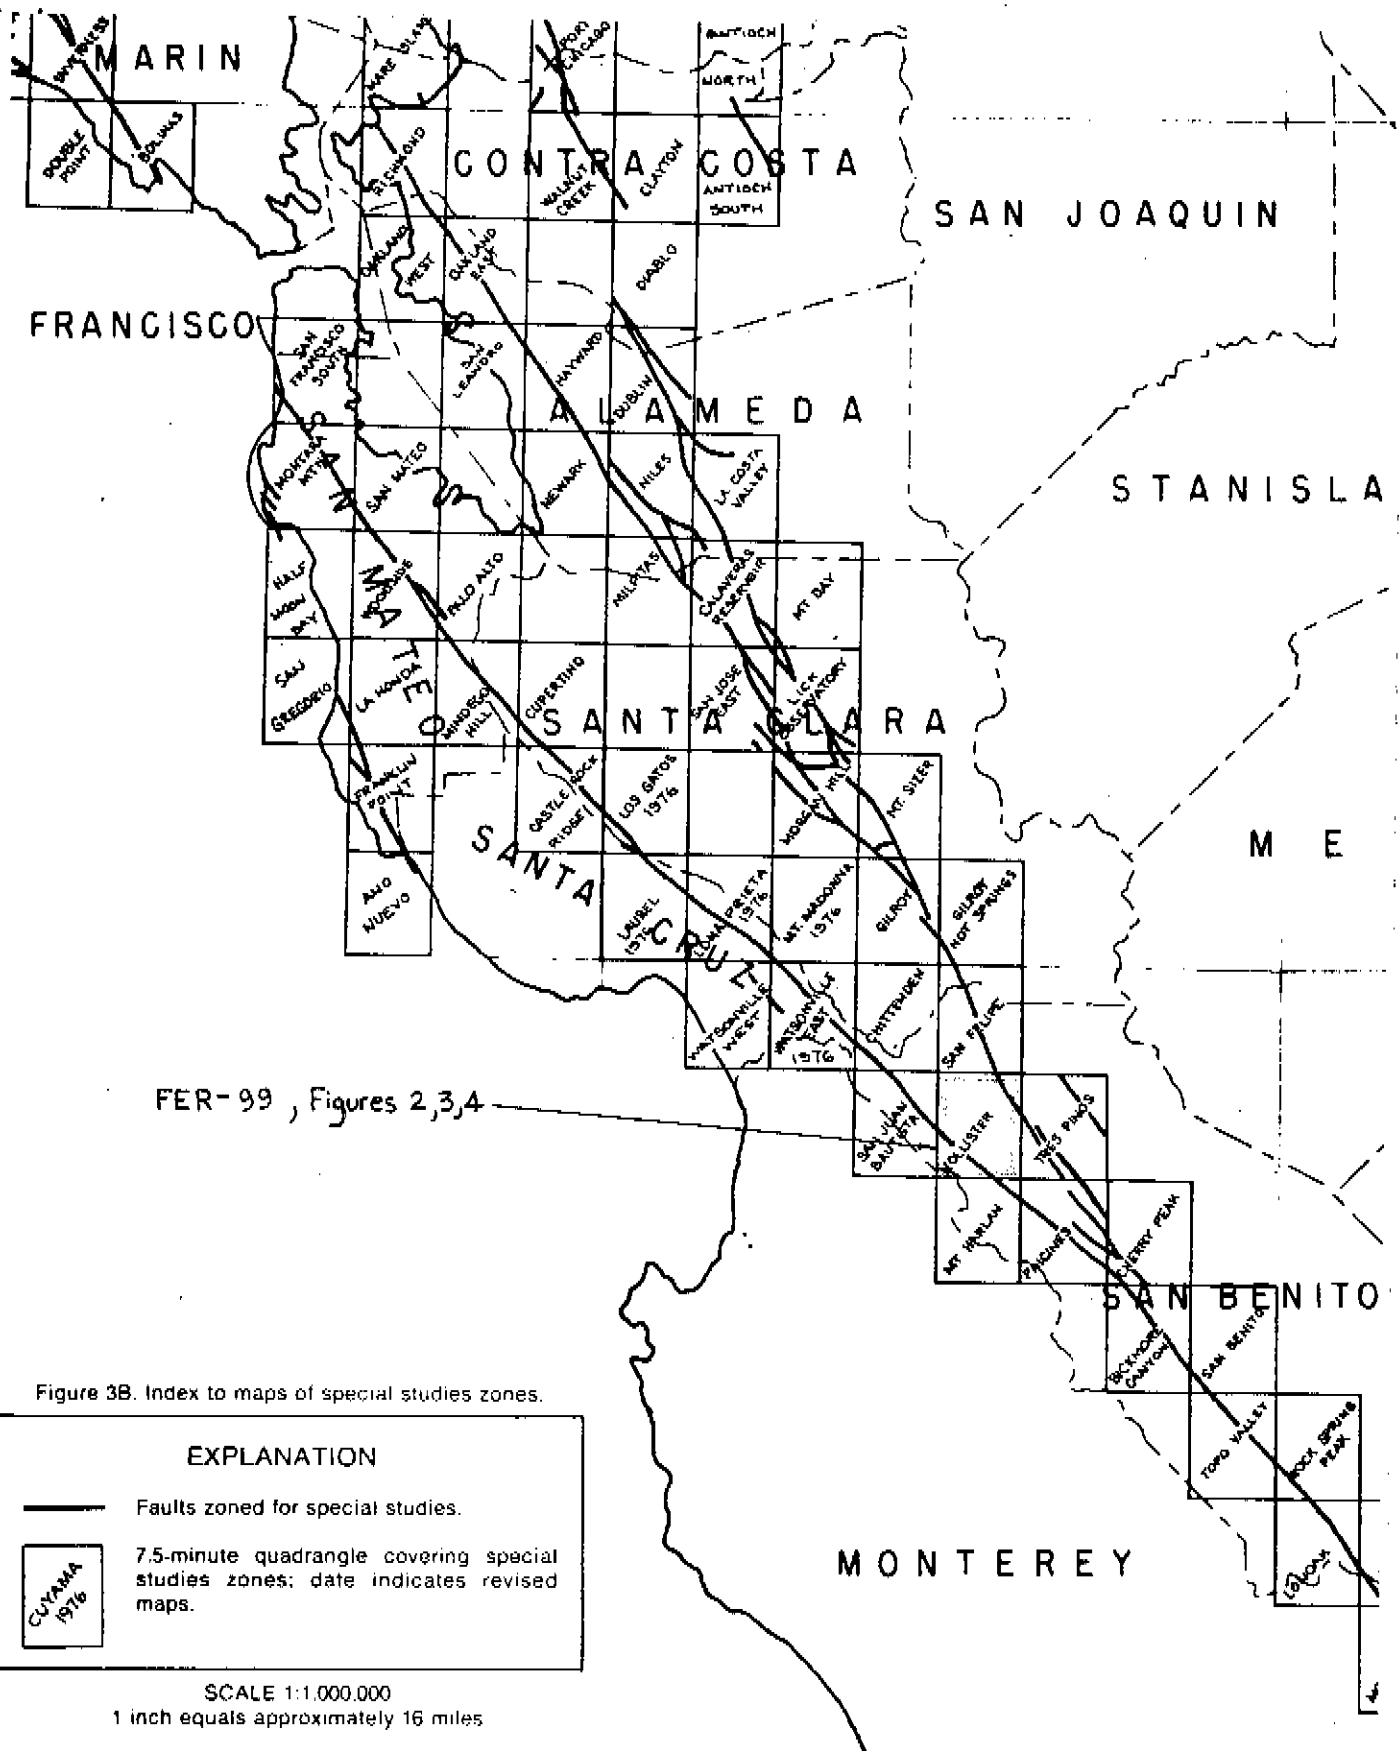
The San Andreas fault zone depicted on the 1974 Special Studies Zones (SSZ) Map of the Hollister 7.5-minute quadrangle was based on fault traces by Taliaferro (1948) and Rogers (1973) (figures 1, 2). Most of the land surface along the fault has not been significantly altered by man, although areas in the Hollister Hills State Vehicular Recreation Area (HHSVRA) have been modified by road grading and offroad vehicle activity.

Figure 1 (to FER-99). Index to main faults and Special Studies Zones, Hollister quadrangle (from CDMG Special Publication 42, p. 13).
